**Subject: Emergency Response Trip Report and Removal Site Evaluation
 Park Warehouse Fire Site, St. Louis, Missouri
 U.S. EPA Region 7 START 4, Contract No. EP-S7-13-06, Task Order No. 0203
 Task Monitor: Heath Smith, EPA On-Scene Coordinator**

**EMERGENCY RESPONSE TRIP REPORT AND REMOVAL SITE EVALUATION
PARK WAREHOUSE FIRE, ST. LOUIS, MISSOURI**

**Superfund Technical Assessment and Response Team (START) 4 Contract
Contract No. EP-S7-13-06, Task Order No. 0203**

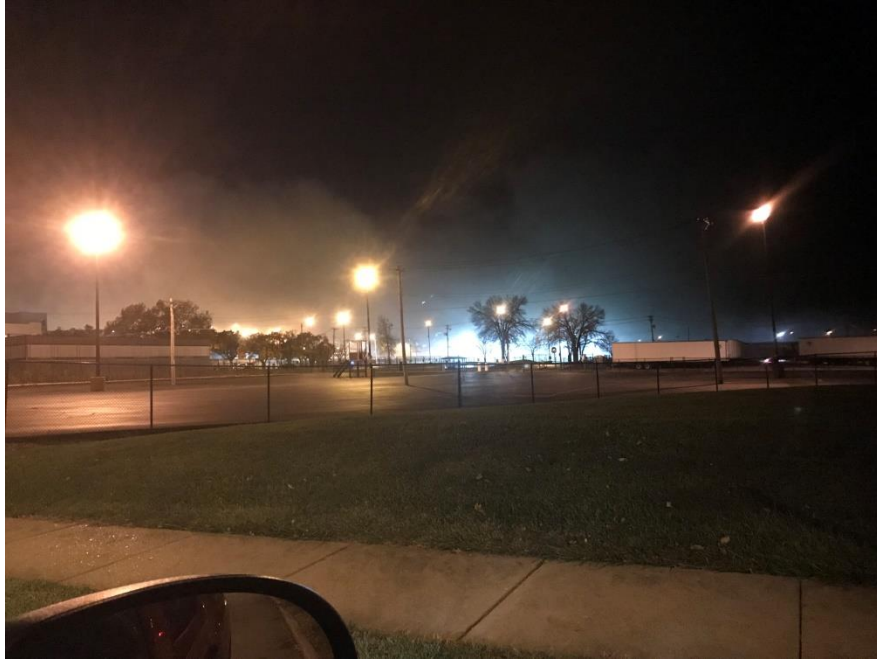
Photo No.: 1	Date: 11/15/2017	Time: 20:35
Photographer: Greg Blattner		Direction: Southwest
Latitude: 38.625105		Longitude: -90.242392
Description: This photograph shows the smoke plume from Park Warehouse fire.

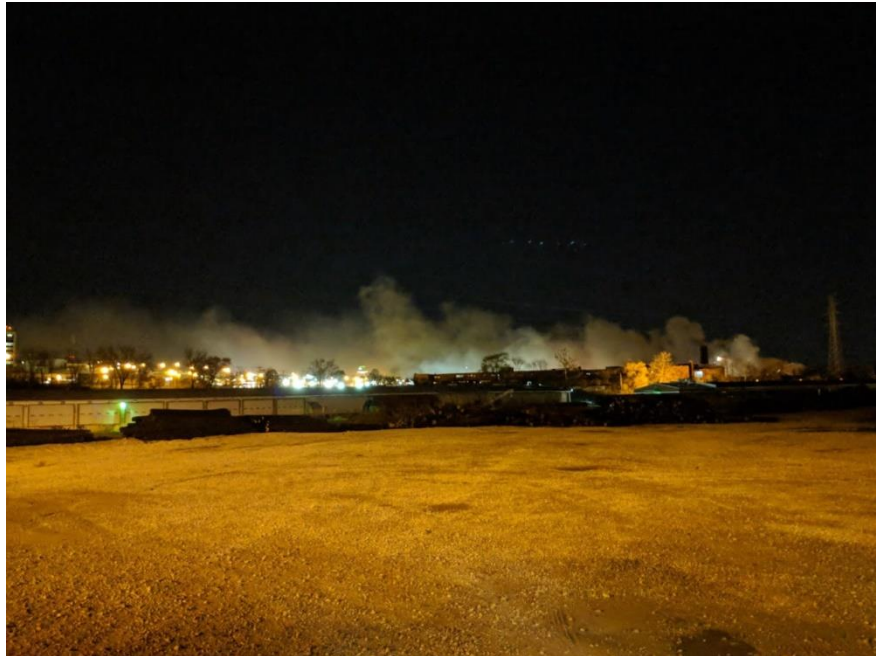
Photo No.: 2	Date: 11/15/2017	Time: 22:15
Photographer: Heath Smith		Direction: South
Latitude: 38.627002	Longitude: -90.243703	
Description: This photograph shows the smoke plume from Park Warehouse fire.

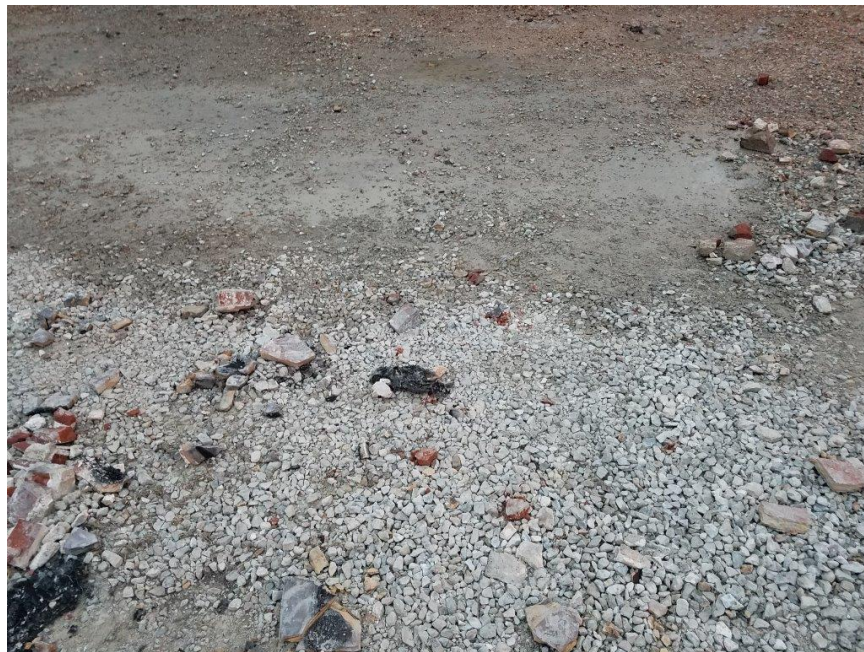
Photo No.: 4	Date: 11/17/2017	Time: 16:46
Photographer: James Christopher		Direction: North
Latitude: 38.621570		Longitude: -90.246346
Description: This photograph shows debris in the parking lot next to Park Warehouse.

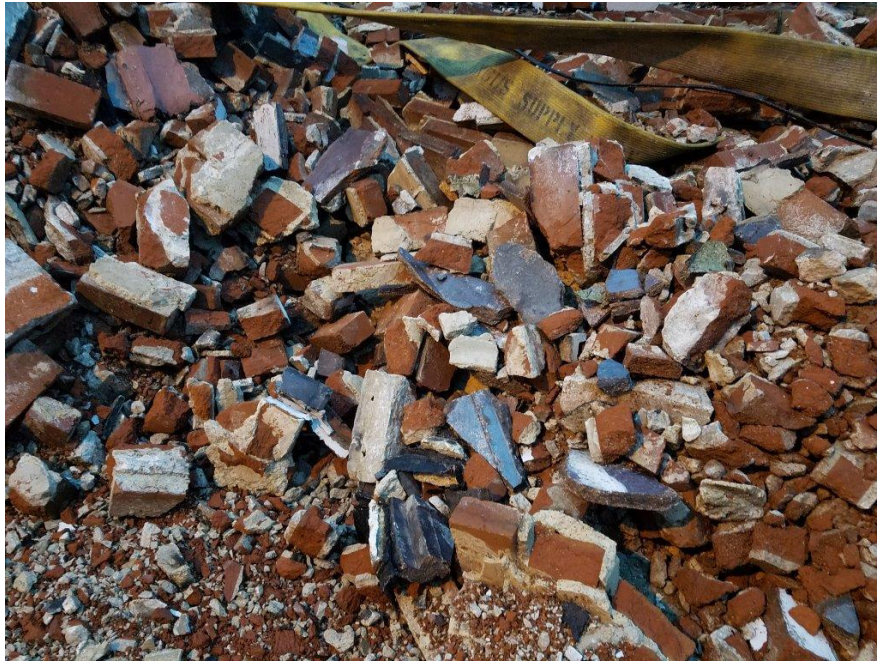
Photo No.: 5	Date: 11/17/2017	Time: 16:46
Photographer: James Christopher		Direction: North
Latitude: 38.621464		Longitude: -90.246018
Description: This photograph shows debris from collapsed wall on south side of Park Warehouse.

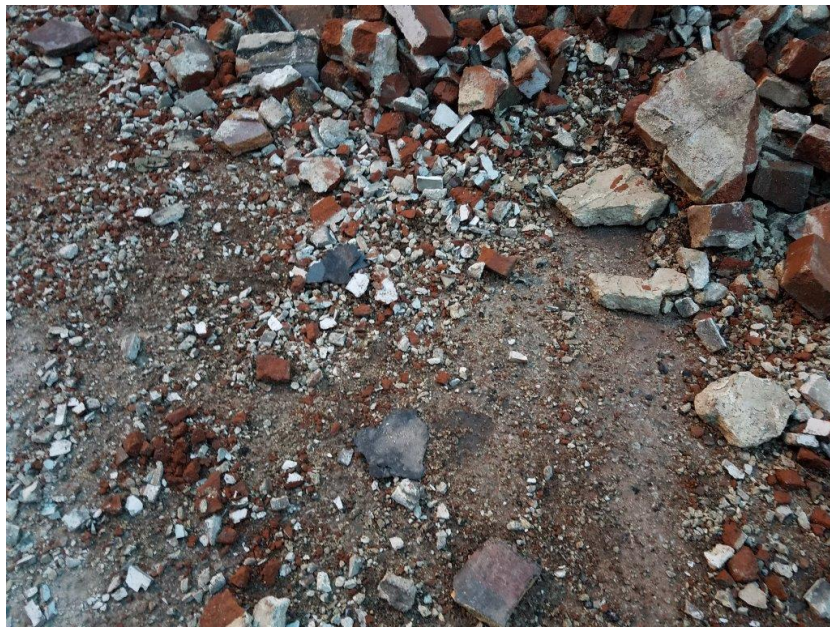
Photo No.: 6	Date: 11/17/2017	Time: 16:46
Photographer: James Christopher		Direction: North
Latitude: 38.621464		Longitude: -90.246018
Description: This photograph shows debris from collapsed wall on south side of Park Warehouse.

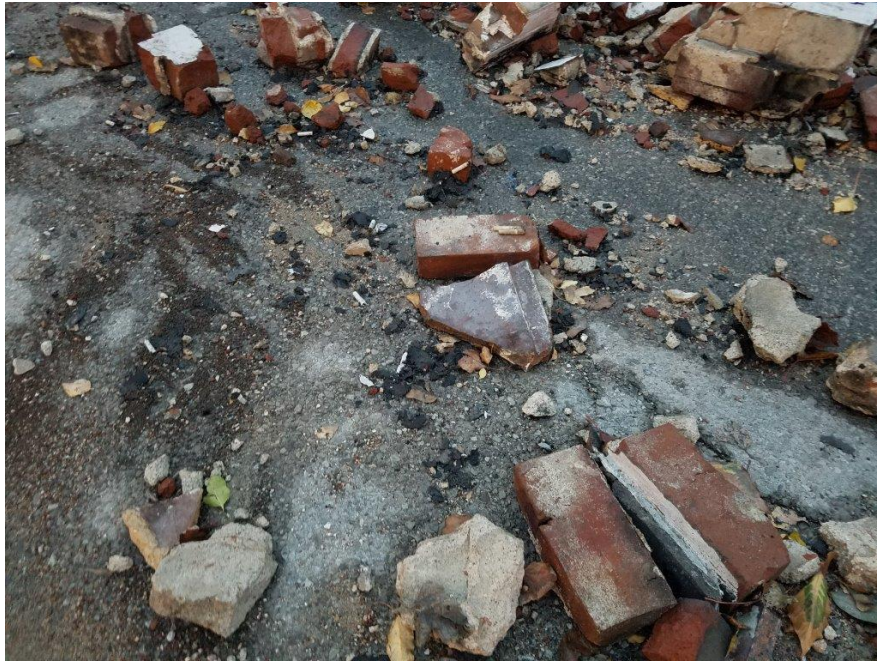
Photo No.: 7	Date: 11/17/2017	Time: 16:47
Photographer: James Christopher		Direction: North
Latitude: 38.621464		Longitude: -90.246018
Description: This photograph shows debris from collapsed wall on south side of Park Warehouse.

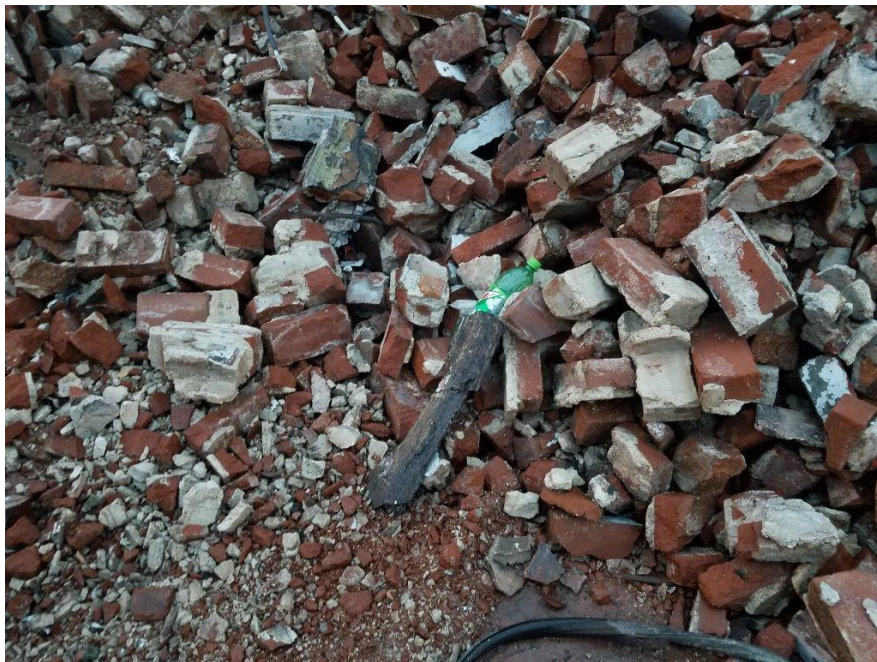
Photo No.: 8	Date: 11/17/2017	Time: 16:47
Photographer: James Christopher		Direction: North
Latitude: 38.621464		Longitude: -90.246018
Description: This photograph shows debris from collapsed wall on south side of Park Warehouse.

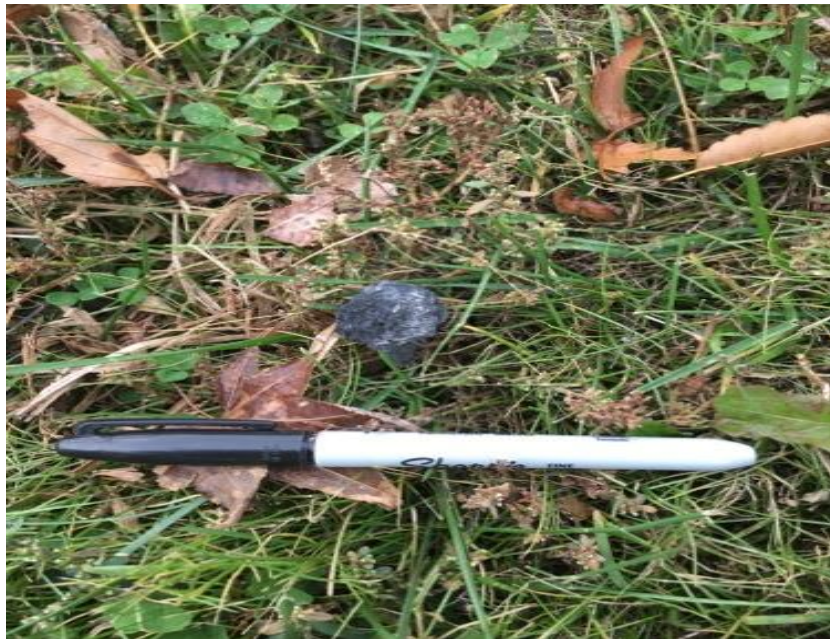
Photo No.: 10	Date: 11/18/2017	Time: 07:59
Photographer: Heath Smith		Direction: South
Latitude: 38.619512	Longitude: -90.245186	
Description: This photograph shows debris sample WF-T2-002 collected from residential neighborhood near Park Warehouse.

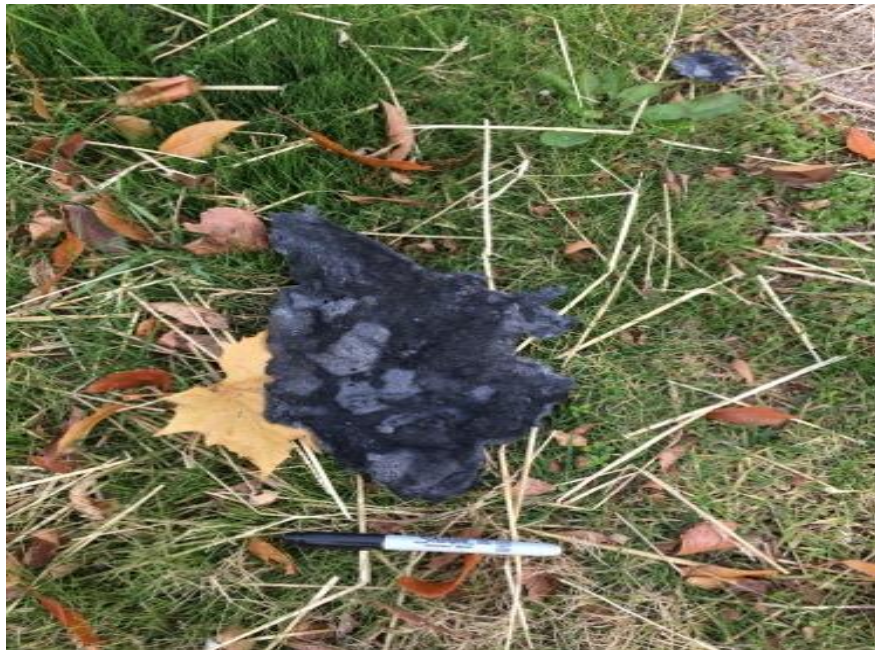
Photo No.: 12	Date: 11/18/2017	Time: 08:06
Photographer: Heath Smith		Direction: North
Latitude: 38.620015		Longitude: -90.244859
Description: This photograph shows debris sample WF-T2-004 collected from residential neighborhood near Park Warehouse.

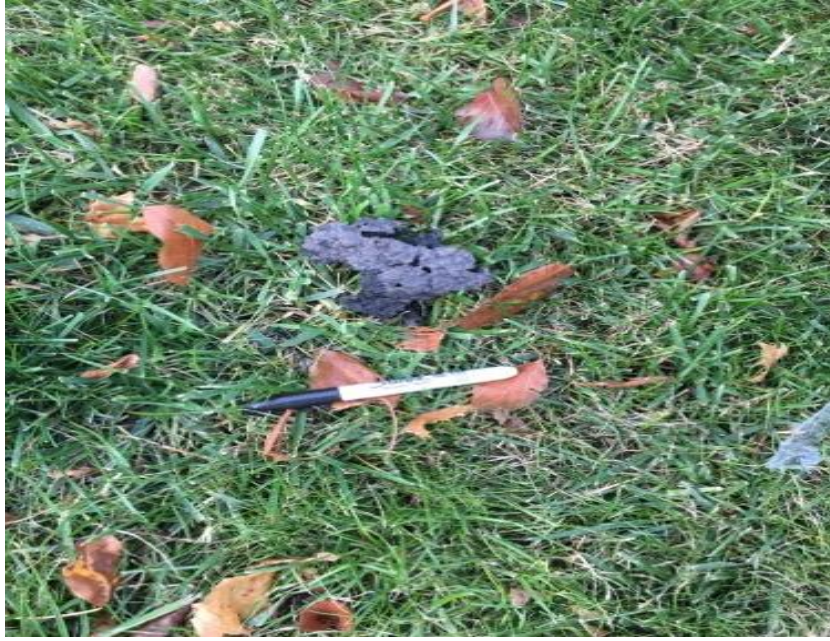
Photo No.: 13	Date: 11/18/2017	Time: 08:18
Photographer: Heath Smith		Direction: Southwest
Latitude: 38.620420		Longitude: -90.245549
Description: This photograph shows debris sample WF-T2-005 collected from residential neighborhood near Park Warehouse.

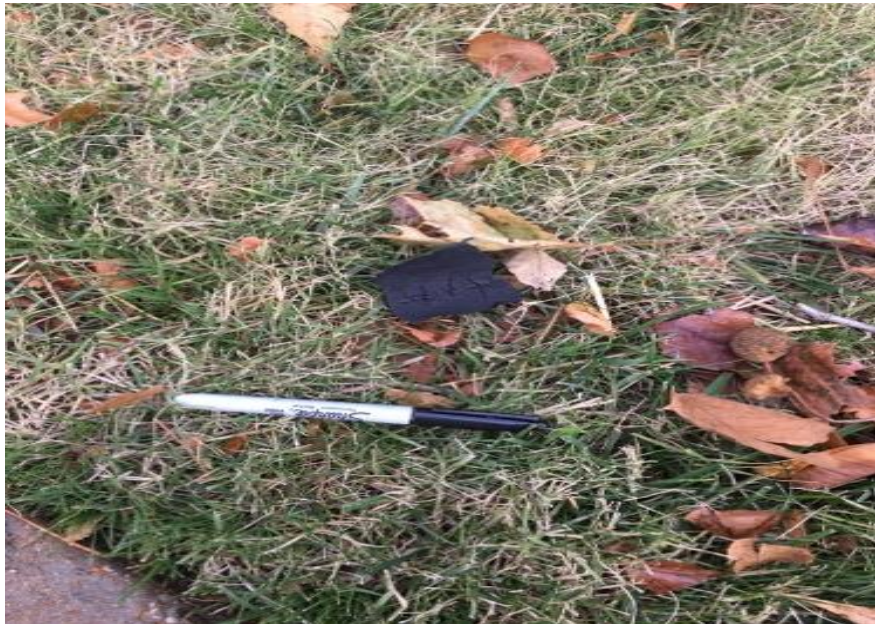
Photo No.: 14	Date: 11/18/2017	Time: 08:22
Photographer: Heath Smith		Direction: Northwest
Latitude: 38.620479	Longitude: -90.244926	
Description: This photograph shows debris sample WF-T2-006 collected from residential neighborhood near Park Warehouse.

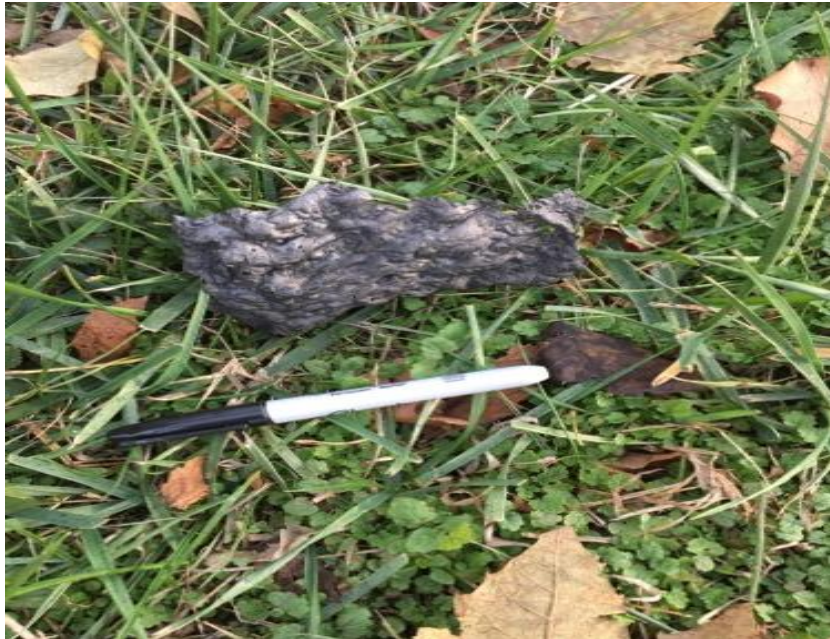
Photo No.: 16	Date: 11/18/2017	Time: 08:31
Photographer: Heath Smith		Direction: Southeast
Latitude: 38.620732		Longitude: -90.244481
Description: This photograph shows debris sample WF-T2-008 collected from residential neighborhood near Park Warehouse.

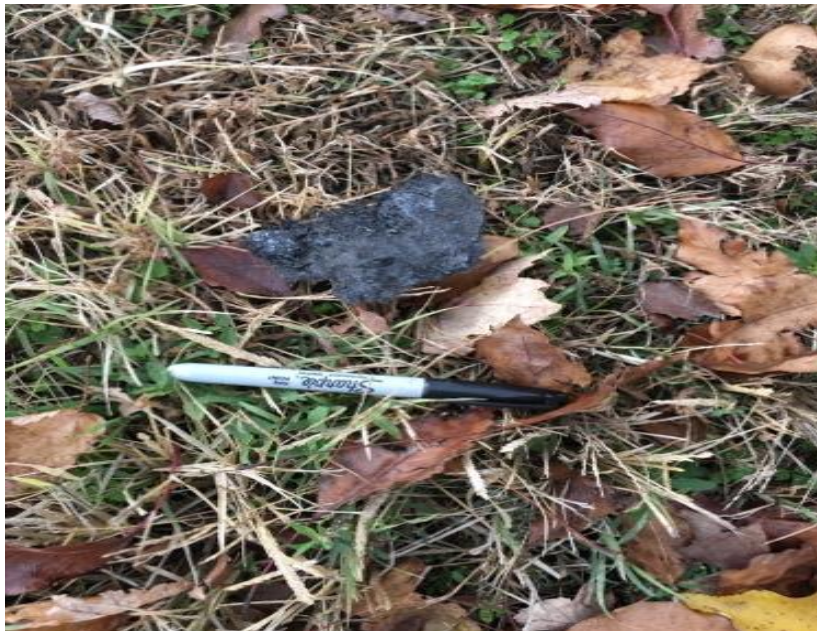
Photo No.: 18	Date: 11/18/2017	Time: 08:39
Photographer: Heath Smith		Direction: Southwest
Latitude: 38.620953	Longitude: -90.245585	
Description: This photograph shows debris sample WF-T2-010 collected from residential neighborhood near Park Warehouse.

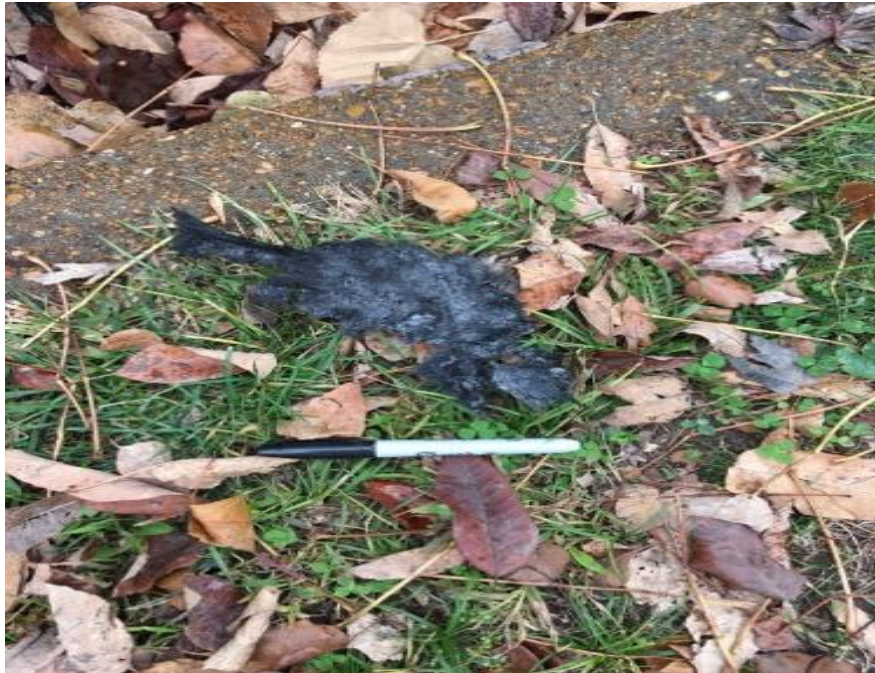
Photo No.: 20	Date: 11/18/2017	Time: 09:17
Photographer: Heath Smith		Direction: South
Latitude: 38.619327		Longitude: -90.241720
Description: This photograph shows debris sample WF-T2-012 collected from residential neighborhood near Park Warehouse.

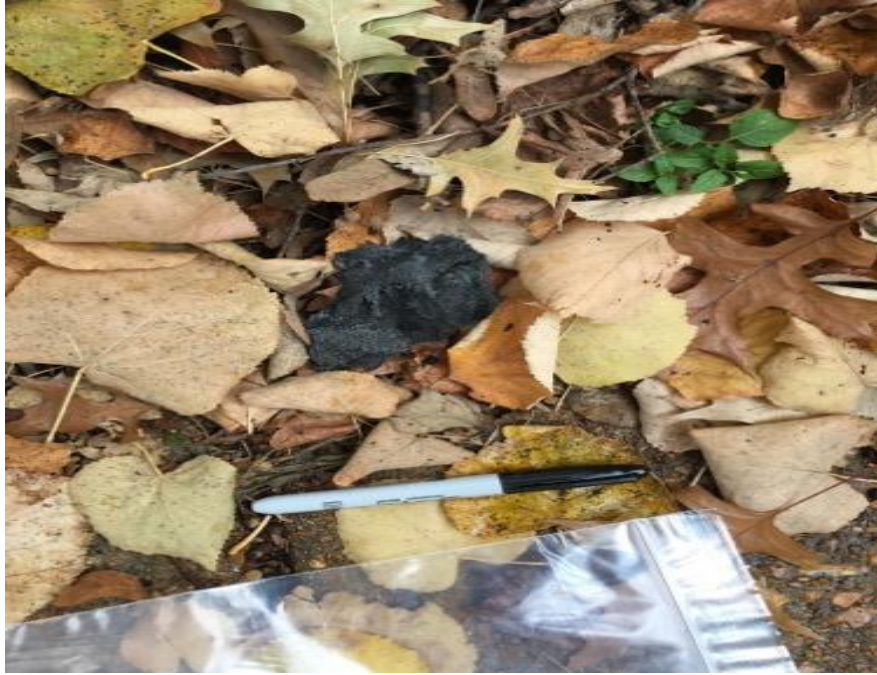
Photo No.: 21	Date: 11/18/2017	Time: 09:20
Photographer: Heath Smith		Direction: North
Latitude: 38.619248		Longitude: -90.241218
Description: This photograph shows debris sample WR-T2-013 collected from residential neighborhood near Park Warehouse.

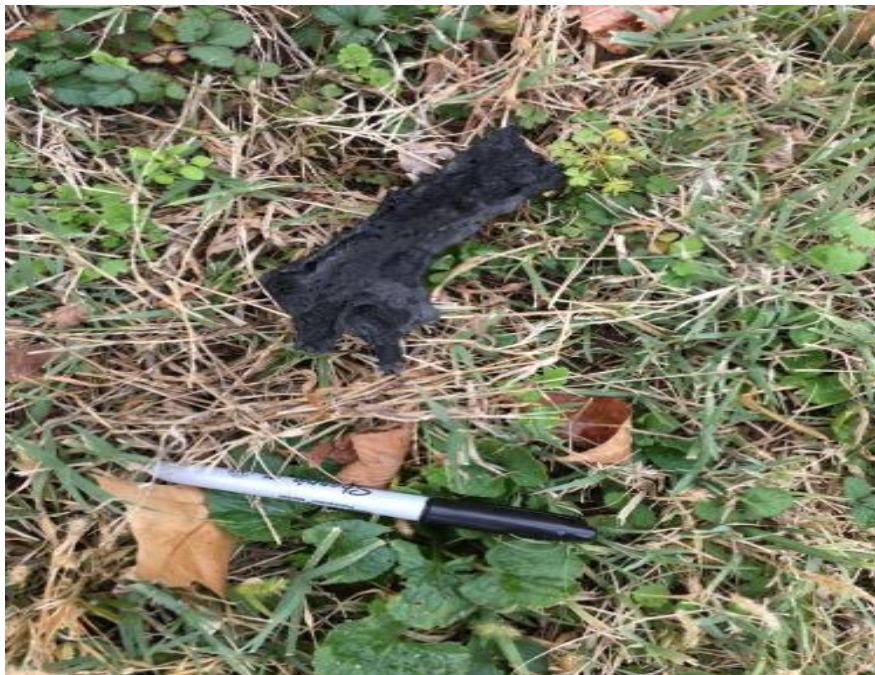
Photo No.: 24	Date: 11/18/2017	Time: 09:33
Photographer: Heath Smith		Direction: North
Latitude: 38.619322		Longitude: -90.239853
Description: This photograph shows debris sample WF-T2-016 collected from residential neighborhood near Park Warehouse.

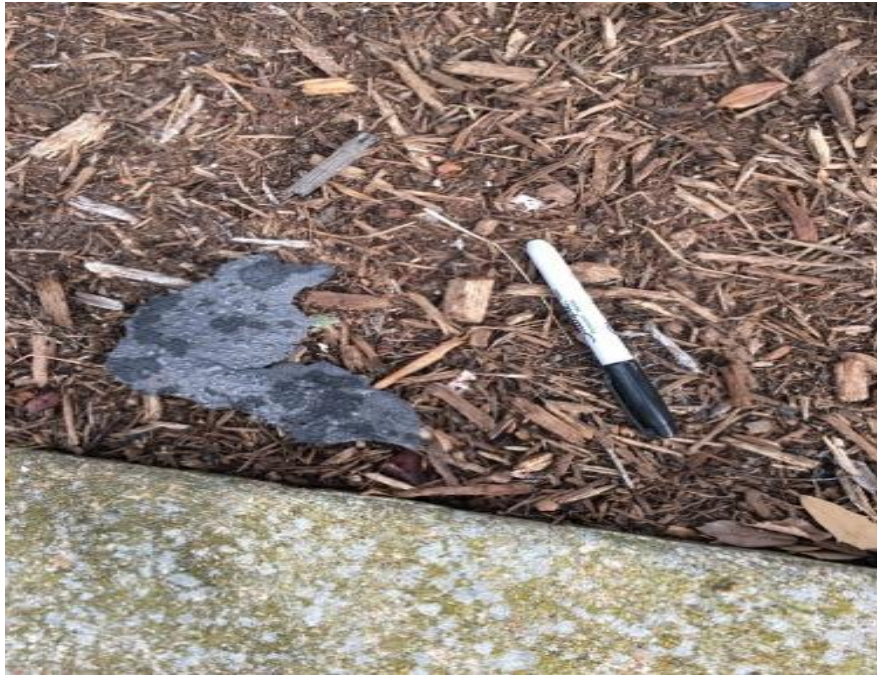
Photo No.: 25	Date: 11/18/2017	Time: 09:38
Photographer: Heath Smith		Direction: North
Latitude: 38.619589		Longitude: -90.241091
Description: This photograph shows debris sample WF-T2-017 collected from residential neighborhood near Park Warehouse.

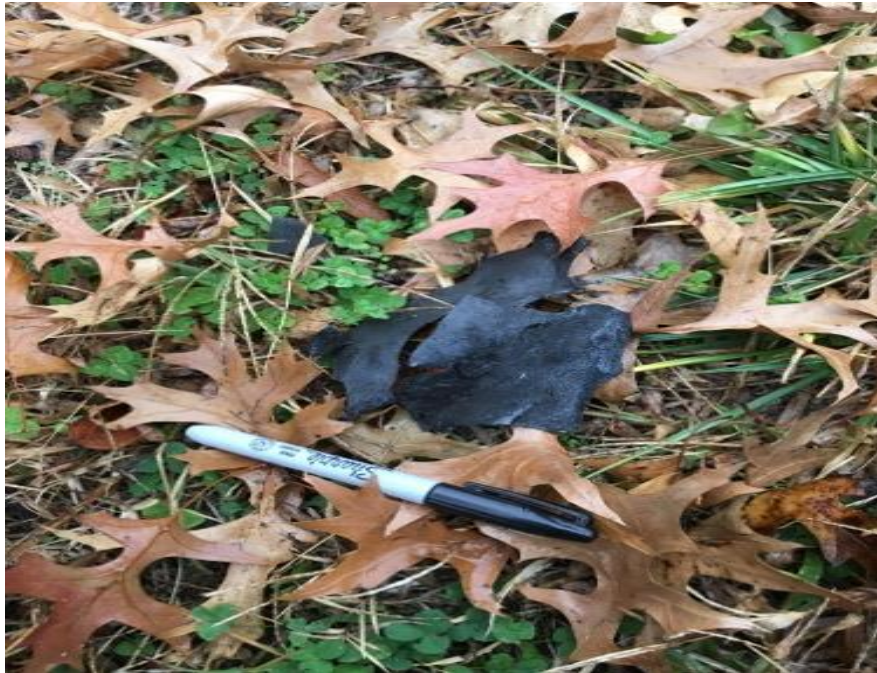
Photo No.: 28	Date: 11/18/2017	Time: 10:55
Photographer: Heath Smith		Direction: North
Latitude: 38.619435		Longitude: -90.242288
Description: This photograph shows debris sample WF-T2-020 collected from residential neighborhood near Park Warehouse.

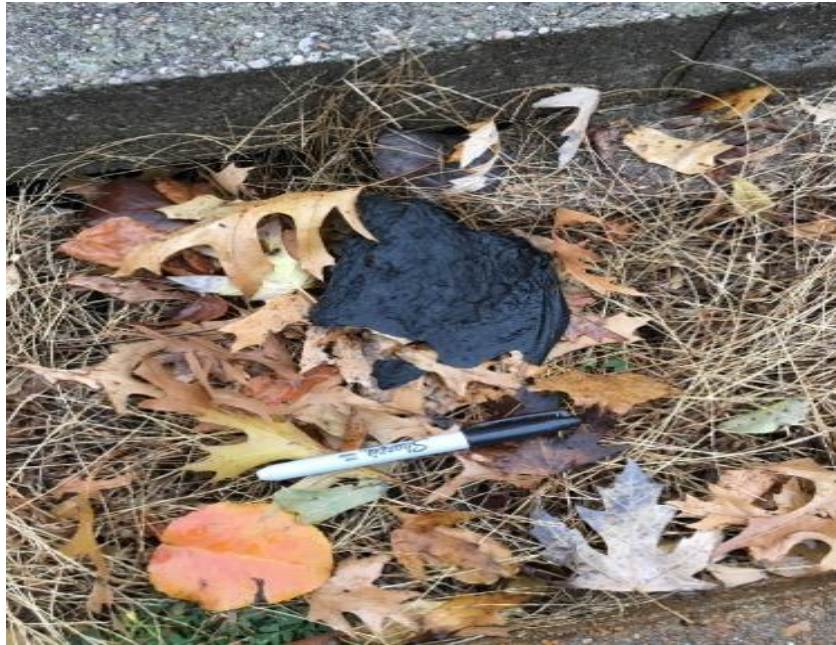
Photo No.: 29	Date: 11/18/2017	Time: 10:57
Photographer: Heath Smith		Direction: East
Latitude: 38.619554		Longitude: -90.242185
Description: This photograph shows debris sample WF-T2-021 collected from residential neighborhood near Park Warehouse.

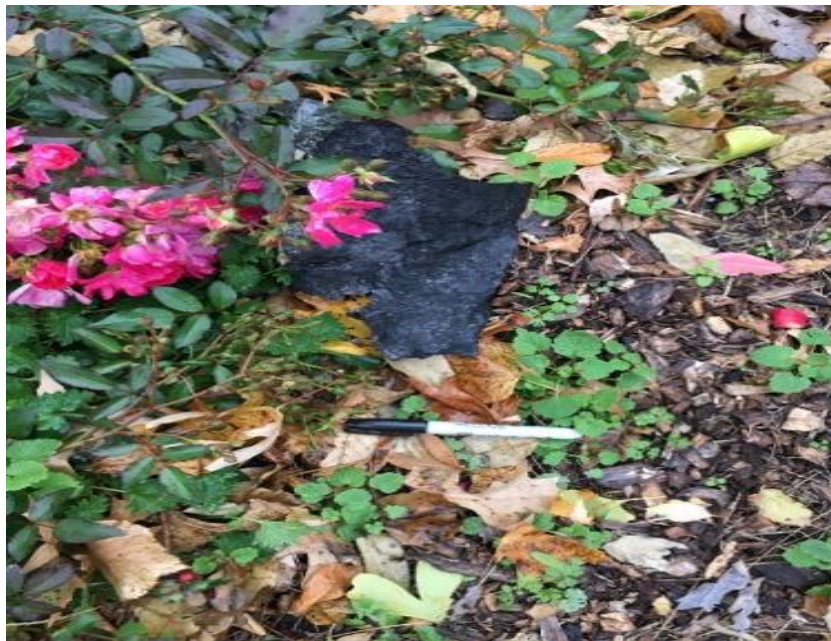
Photo No.: 30	Date: 11/18/2017	Time: 10:59
Photographer: Heath Smith		Direction: East
Latitude: 38.619690		Longitude: -90.242090
Description: This photograph shows debris sample WF-T2-022 collected from residential neighborhood near Park Warehouse.

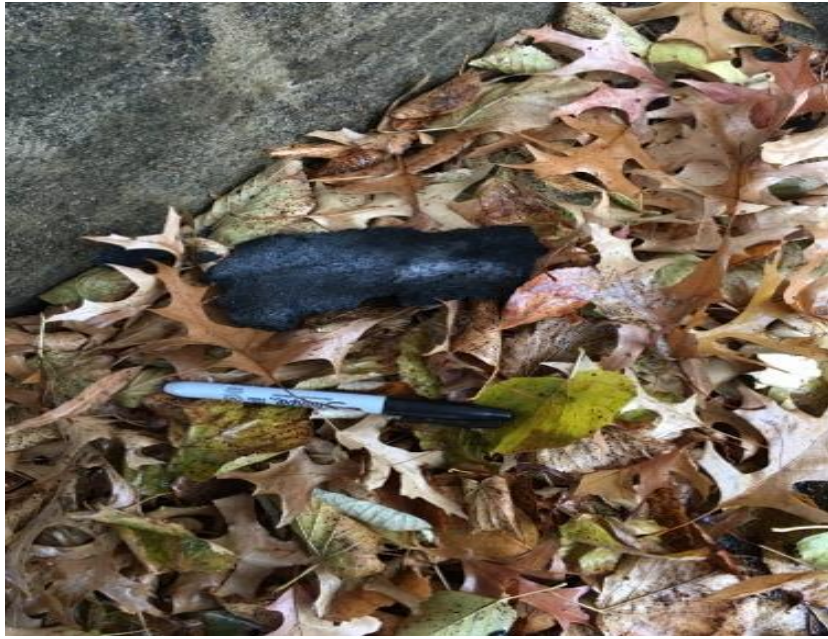
Photo No.: 31	Date: 11/18/2017	Time: 11:02
Photographer: Heath Smith		Direction: East
Latitude: 38.619318	Longitude: -90.242329	
Description: This photograph shows debris sample WF-T2-023 collected from residential neighborhood near Park Warehouse.

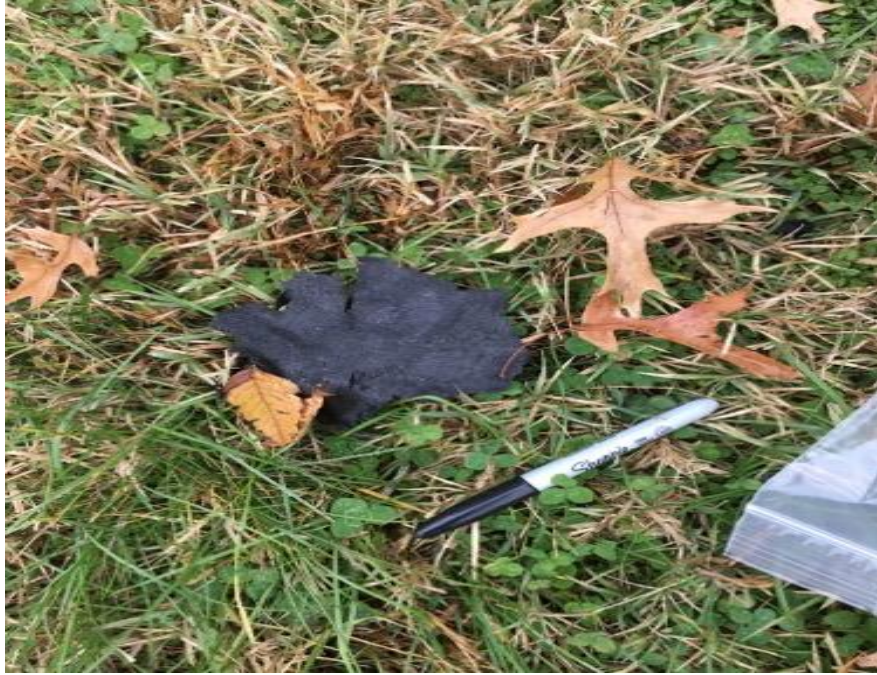
Photo No.: 33	Date: 11/18/2017	Time: 11:09
Photographer: Heath Smith		Direction: North
Latitude: 38.618699		Longitude: -90.242397
Description: This photograph shows debris sample WF-T2-025 collected from residential neighborhood near Park Warehouse.

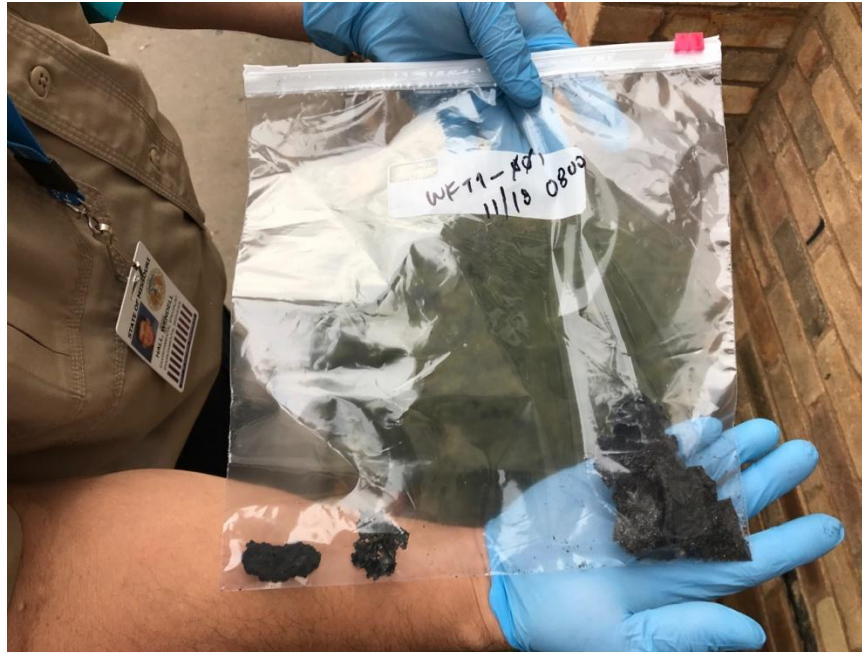
Photo No.: 35	Date: 11/18/2017	Time: 08:00
Photographer: Greg Blattner		Direction: South
Latitude: 38.62121		Longitude: -90.24416
Description: This photograph shows debris sample WF-T1-001 collected from residential neighborhood near Park Warehouse.

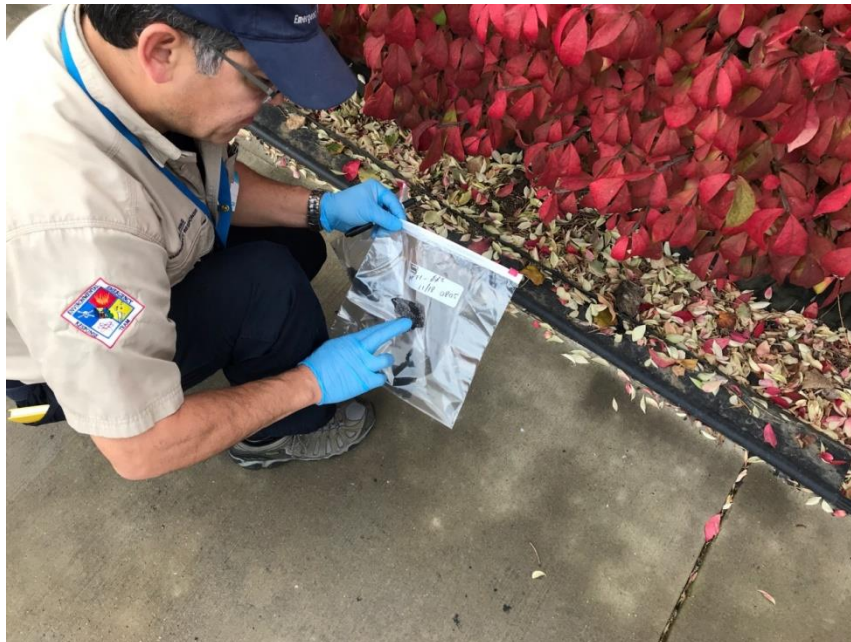
Photo No.: 36	Date: 11/18/2017	Time: 08:05
Photographer: Greg Blattner		Direction: South
Latitude: 38.62121	Longitude: -90.24391	
Description: This photograph shows debris sample WF-T1-002 collected from residential neighborhood near Park Warehouse.

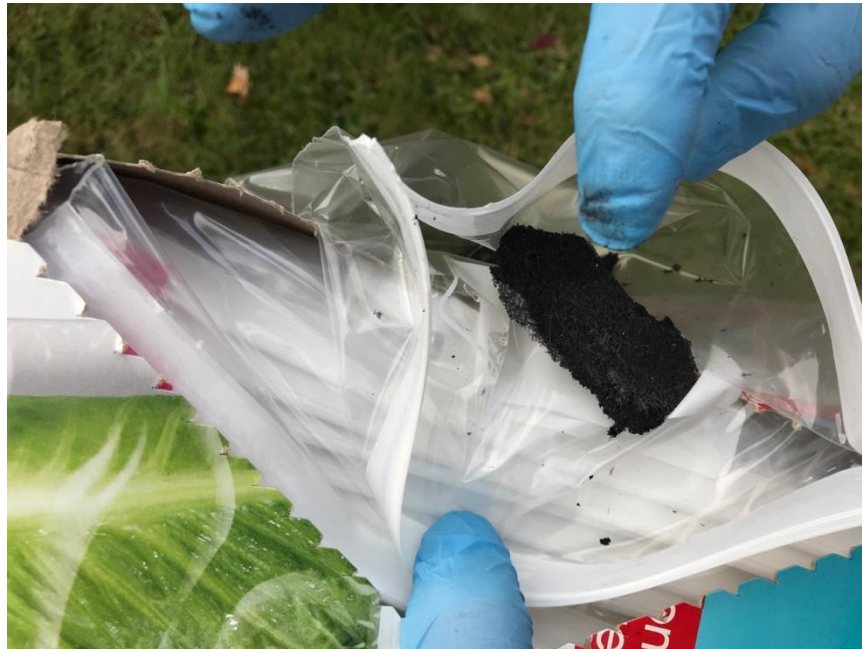
Photo No.: 38	Date: 11/18/2017	Time: 08:10
Photographer: Greg Blattner		Direction: South
Latitude: 38.62118		Longitude: -90.24360
Description: This photograph shows debris sample WF-T1-003 collected from residential neighborhood near Park Warehouse.

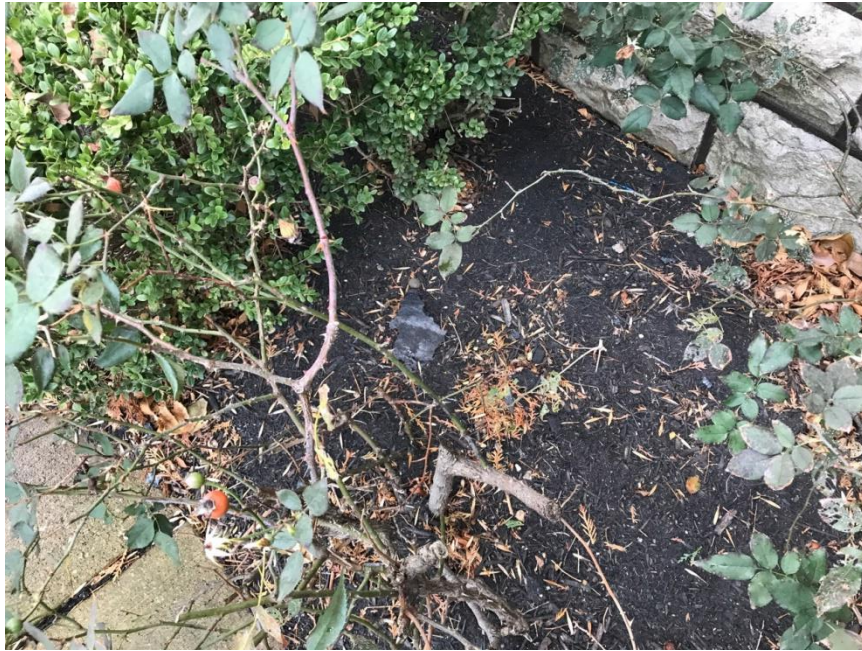
Photo No.: 39	Date: 11/18/2017	Time: 08:12
Photographer: Greg Blattner		Direction: South
Latitude: 38.62115		Longitude: -90.24324
Description: This photograph shows debris sample WF-T1-004 collected from residential neighborhood near Park Warehouse.

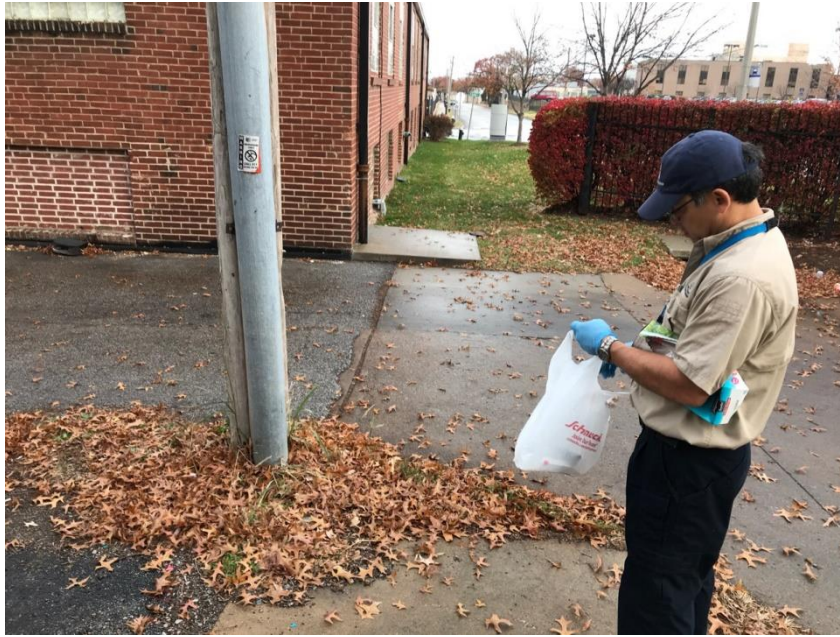
Photo No.: 43	Date: 11/18/2017	Time: 08:20
Photographer: Greg Blattner		Direction: North
Latitude: 38.62065	Longitude: -90.24192	
Description: This photograph shows debris sample WF-T1-006 collected from residential neighborhood near Park Warehouse.

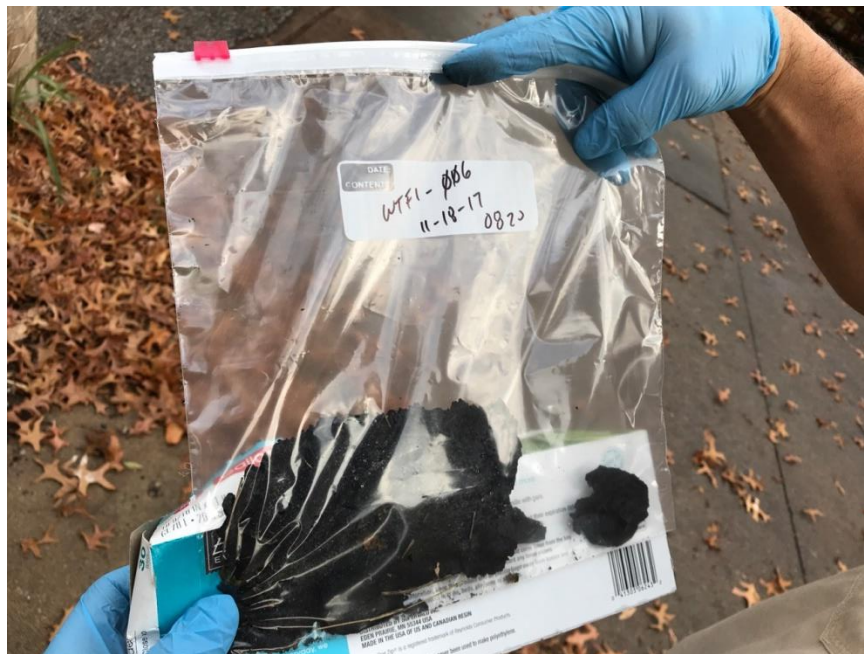
Photo No.: 44	Date: 11/18/2017	Time: 08:20
Photographer: Greg Blattner		Direction: North
Latitude: 38.62065	Longitude: -90.24192	
Description: This photograph shows debris sample WF-T1-006 collected from residential neighborhood near Park Warehouse.

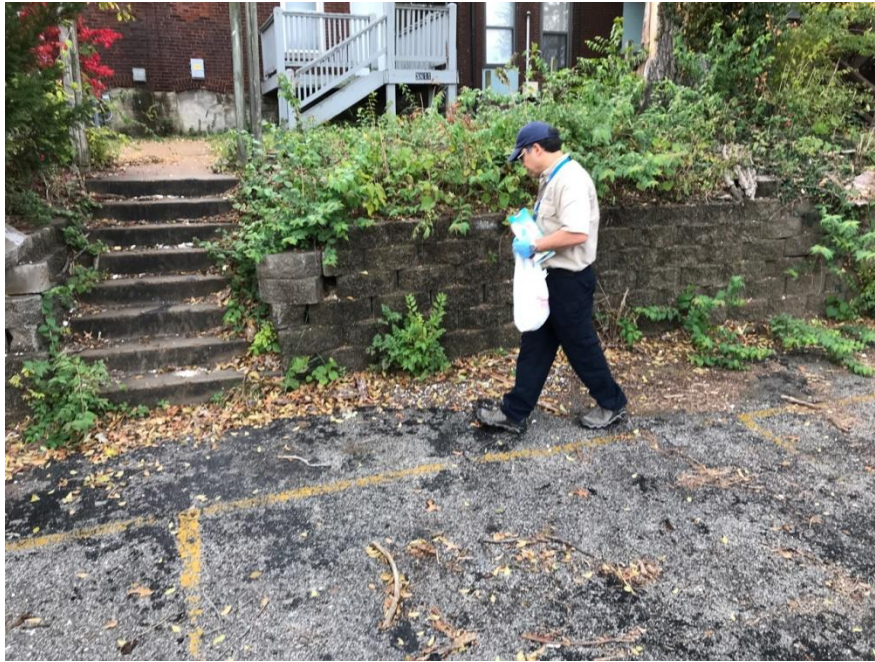
Photo No.: 45	Date: 11/18/2017	Time: 08:23
Photographer: Greg Blattner		Direction: North
Latitude: 38.62060		Longitude: -90.24233
Description: This photograph shows debris sample WF-T1-007 collected from residential neighborhood near Park Warehouse.

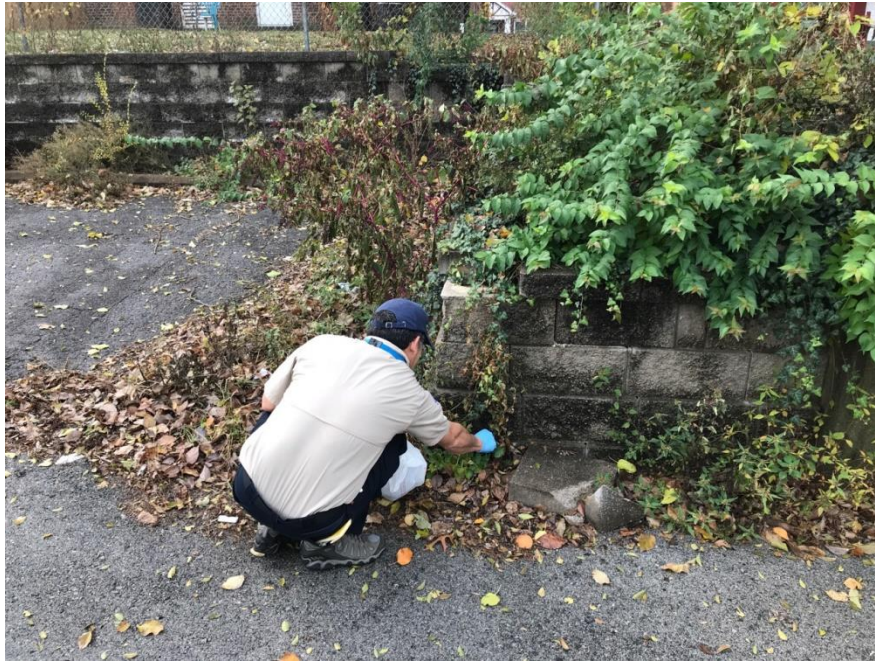
Photo No.: 47	Date: 11/18/2017	Time: 08:28
Photographer: Greg Blattner		Direction: North
Latitude: 38.62073	Longitude: -90.24297	
Description: This photograph shows debris sample WF-T1-008 collected from residential neighborhood near Park Warehouse.

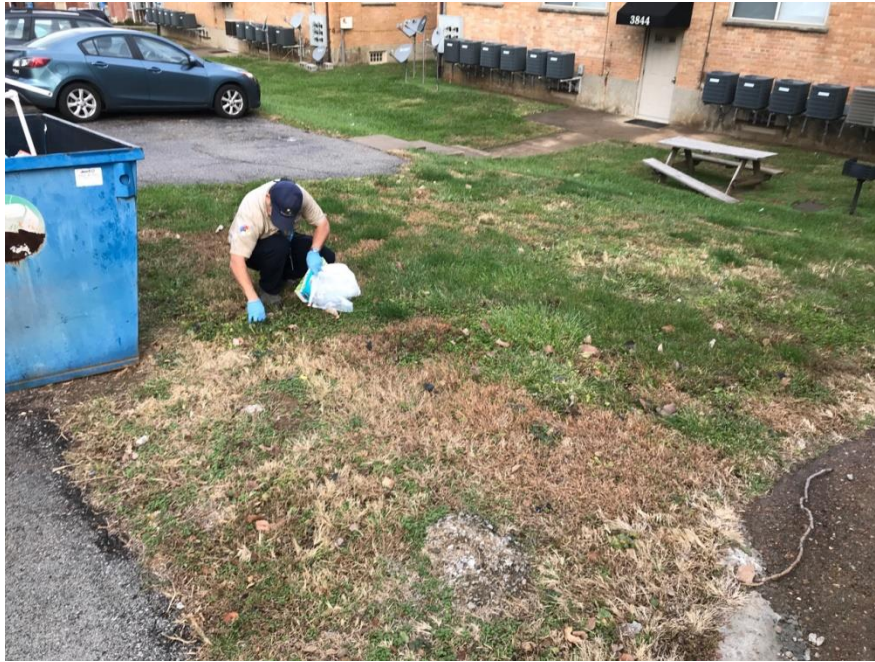
Photo No.: 49	Date: 11/18/2017	Time: 08:30
Photographer: Greg Blattner		Direction: Northwest
Latitude: 38.62081		Longitude: -90.24338
Description: This photograph shows debris sample WF-T1-009 collected from residential neighborhood near Park Warehouse.

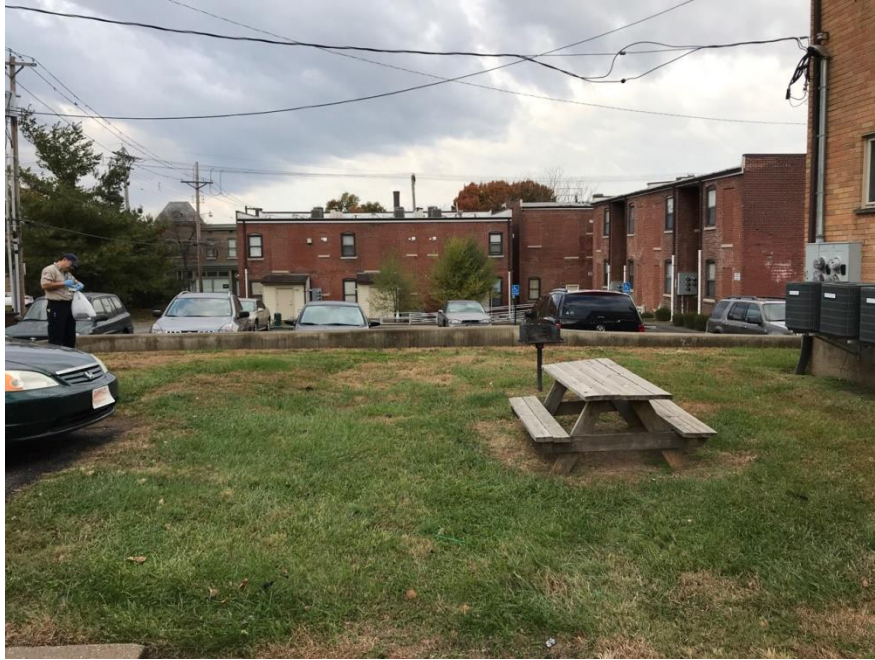
Photo No.: 51	Date: 11/18/2017	Time: 08:35
Photographer: Greg Blattner		Direction: North
Latitude: 38.62090	Longitude: -90.24376	
Description: This photograph shows debris sample WF-T1-010 collected from residential neighborhood near Park Warehouse.

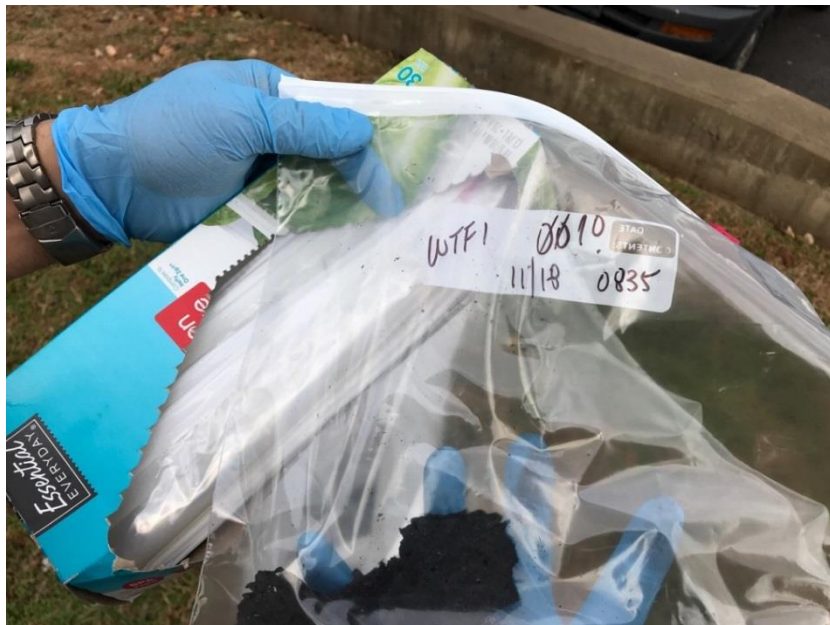
Photo No.: 52	Date: 11/18/2017	Time: 08:35
Photographer: Greg Blattner		Direction: North
Latitude: 38.62090	Longitude: -90.24376	
Description: This photograph shows debris sample WF-T1-010 collected from residential neighborhood near Park Warehouse.

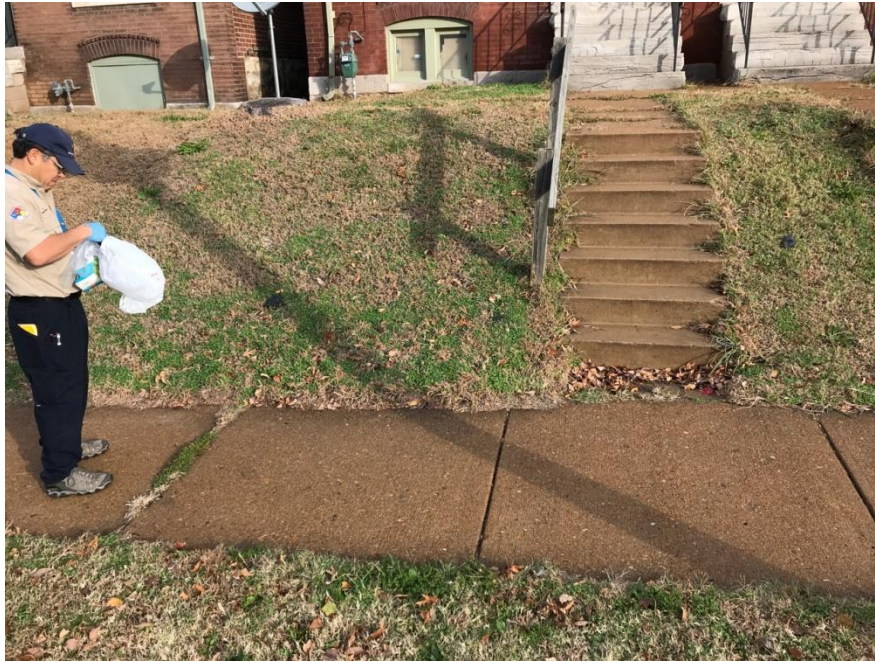
Photo No.: 53	Date: 11/18/2017	Time: 08:43
Photographer: Greg Blattner		Direction: North
Latitude: 38.62026	Longitude: -90.24213	
Description: This photograph shows debris sample WF-T1-011 collected from residential neighborhood near Park Warehouse.

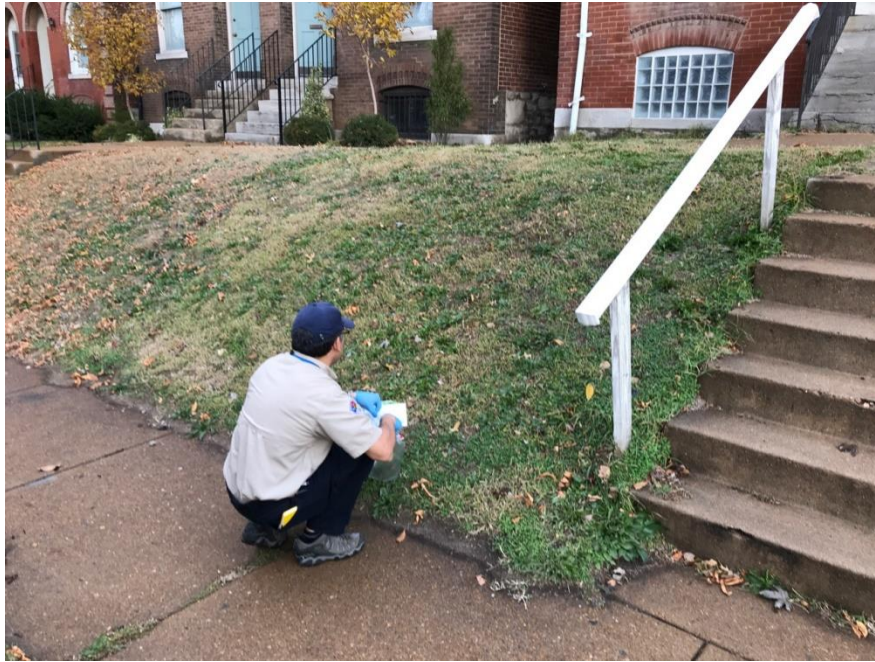
Photo No.: 55	Date: 11/18/2017	Time: 08:45
Photographer: Greg Blattner		Direction: Northwest
Latitude: 38.62028		Longitude: -90.24234
Description: This photograph shows debris sample WF-T1-012 collected from residential neighborhood near Park Warehouse.

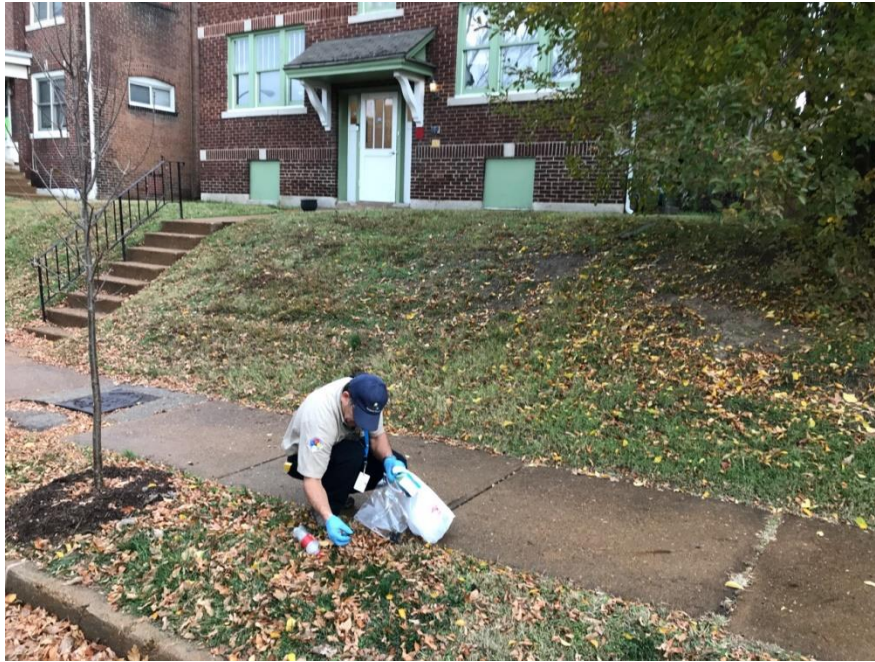
Photo No.: 57	Date: 11/18/2017	Time: 08:48
Photographer: Greg Blattner		Direction: Northwest
Latitude: 38.62032	Longitude: -90.24269	
Description: This photograph shows debris sample WF-T1-013 collected from residential neighborhood near Park Warehouse.
